**Flood Control Project Maintenance
Levee Inspections**

Fall 2019 Levee Maintenance Deficiency Summary Report

San Joaquin River Basin

Madera County FCWCA

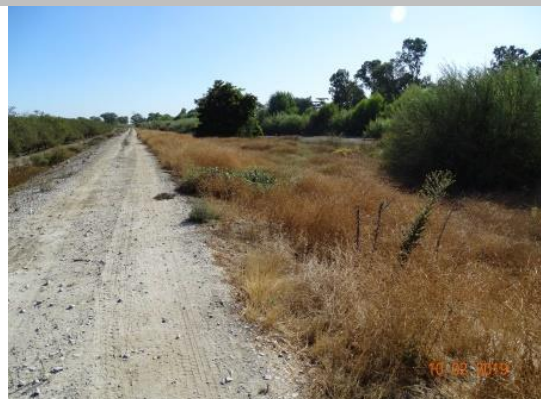
Photo 1 of 1 : FA_2019_NA0011_142_9_20191008_00030.jpg

View of vegetation on waterside slope looking upstream. (Fall 2019)

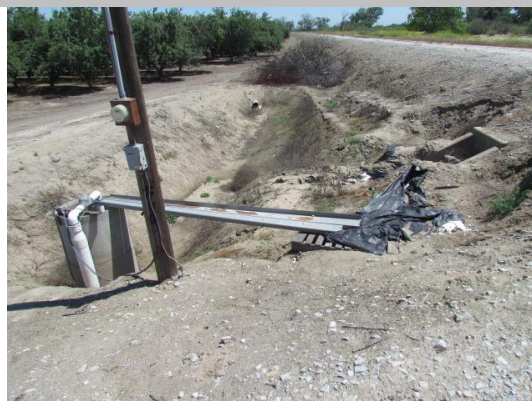
Photo 1 of 1 : FA_2019_NA0011_142_18_20190912_00007.jpg

LM Start	0.03	Rating **	U	Issue No.	18
LM End	0.06	Issue Type +	En	Location *	LS
Category	Earthen Levee			GPS Latitude/Longitude	
				Start	End
Item	Encroachments			37.046566 °	37.046715 °
				-120.427512 °	-120.426964 °
DWR ID	DWR_NA0011_01_s_2014_18				
Comment Code					
DT : Ditch					
Inspector Comment					
There seem to be lots of activity going on at this location. This ditch will cause more damage to the levee slope and toe.

Ash Slough looking upstream from the landside slope levee mile 0.03.

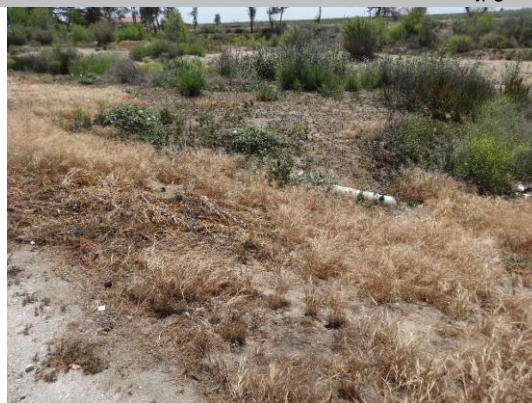
Photo 1 of 3 : UCIP_FA_2019_53153_69674.jpg

Comment Code						
Inspector Comment						
DS_ID:21513 FS_ID:53153 EP_NO: N/A Repair Type: Urgent Crossing Status: Found UCIP Comments: 10/31/2018 Erosion present on both the right and the left side of the concrete headwall located on the LS. Pipe inlet is about 50 percent filled with soil. WS outlet is at a low point, water will pond against the levee until it reaches channel elevation. This crossing does not properly drain to the channel. Levee is composed of highly erodible material. Recommend clearing soil from pipe and completing internal pipe inspection to determine pipe integrity through levee. (O. Magana - DWR UCIP) 07/14/2016 No inspection completed--need to inspect October 2016. (DWR UCIP - omagana)05/06/2014 Landward slope has been excavated and a berm built in front of landward headwall. Sediment visible inside pipe from landward side. Dense vegetation limits the inspector's visibility to identify signs of pipe failure (leaks) along the waterward slope. Recommend removing vegetation along pipe alignment and waterward headwall to conduct proper inspection of structure. (DWR UCIP - omagana) FIELD_STRUCT_DESC: 30-inch corrugated metal gravity drainage pipe through the levee, 9.5 feet below the crown. Headwall and wing wall on each end. Flap gate on the waterside (WS) end. [Additional Reference(s): DWR Levee Log, 2005]. FS Date: 10/31/2018 11:25:00 AM

View of WS--dense vegetation along WS slope.

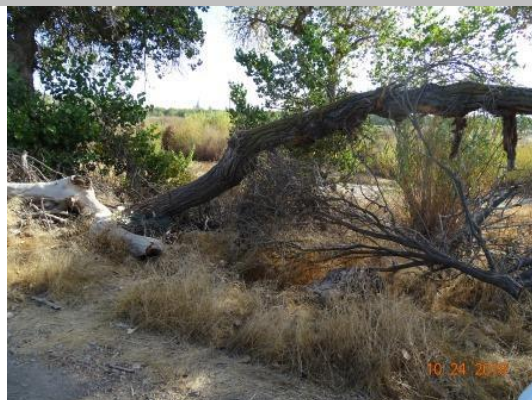
Photo 1 of 1 : FA_2019_NA0011_142_25_20190912_00010.jpg

tree limbs and trunks on waterside shoulder and slope. (Fall 2018)

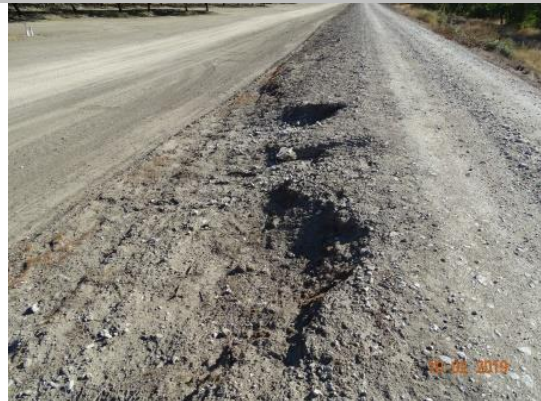
Photo 1 of 3 : FA_2019_NA0011_142_29_20191008_00037.jpg

LM Start	1.04	Rating **	M	Issue No.	29
LM End	1.04	Issue Type +	Ma	Location *	LS
Category	Earthen Levee			GPS Latitude/Longitude	
				Start	End
Item	Erosion / Bank Caving			37.055880 °	37.055880 °
				-120.414628 °	-120.414628 °
DWR ID	DWR_NA0011_01_f_2018_29				
Comment Code					
E2 : Schedule repair of erosion site prior to the next inspection.					
Inspector Comment

View of erosion looking upstream along the landside slope. (Fall 2019)

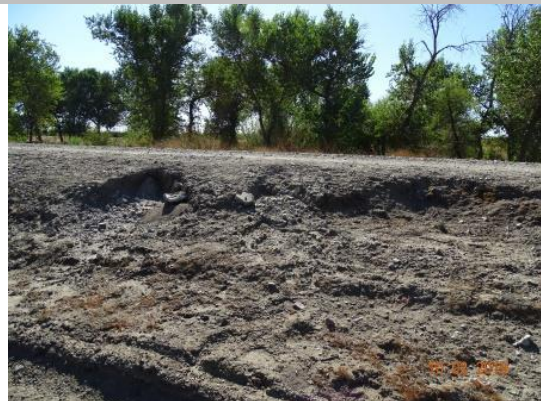
Photo 2 of 3 : FA_2019_NA0011_142_29_20191008_00036.jpg

View of erosion looking up the landside slope. (Fall 2019)

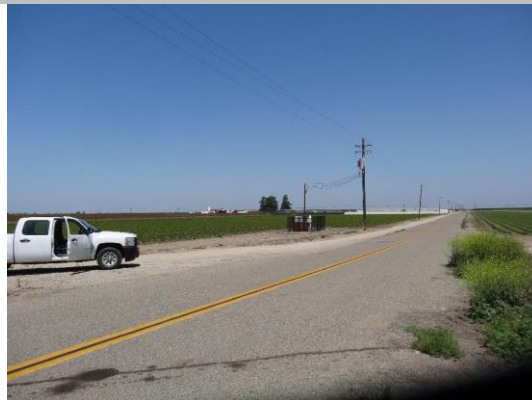
Photo 1 of 3 : UCIP_FA_2019_52847_71800.jpg

LM Start	2.10	Rating **	M	Issue No.	48
LM End	2.10	Issue Type +	En	Location *	
Category	Supplemental			GPS Latitude/Longitude	
				Start	End
Item	DRAFT DWR UCIP Field Study			37.065649 °	37.065649 °
				-120.400663 °	-120.400663 °
DWR ID	25042				
Comment Code					
Inspector Comment					
DS_ID:25042 FS_ID:52847 EP_NO: N/A Repair Type: Non-Urgent Crossing Status: Found UCIP Comments: 05/06/2014 Need to contact owner to determine if crossing goes through levee. (DWR UCIP - O. Magana) FIELD_STRUCT_DESC: 10-inch or 12-inch drainage discharge pipe of an unknown material through the levee, at an unknown depth. Crossing visible inside a concrete standpipe on the waterside (WS). Potential pump station on the landside (LS), approximately 100 feet from the standpipe. This crossing was field discovered. FS Date: 5/6/2014

Pump station visible approximately 100 feet from concrete standpipe.

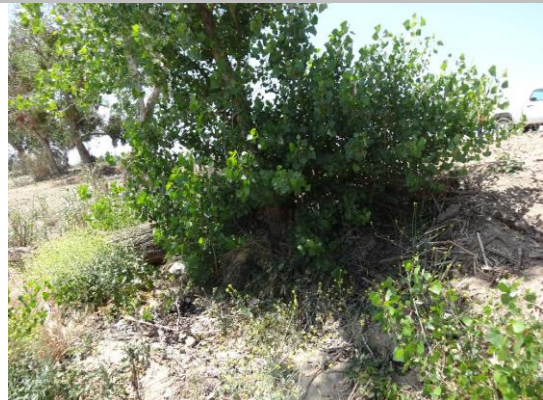
Photo 2 of 3 : UCIP_FA_2019_52848_69678.jpg

View of waterward slope--no signs of crossing visible.

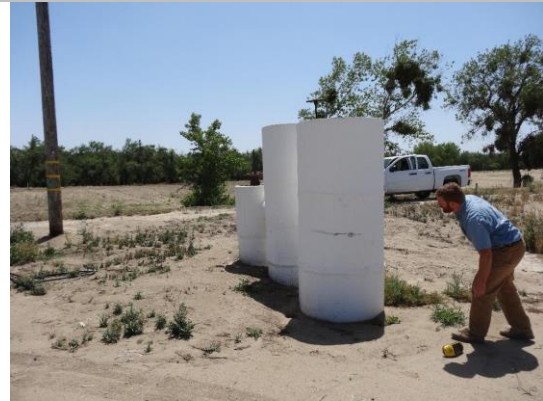
Photo 3 of 3 : UCIP_FA_2019_52848_69677.jpg

Three stand pipes visible on landward side.

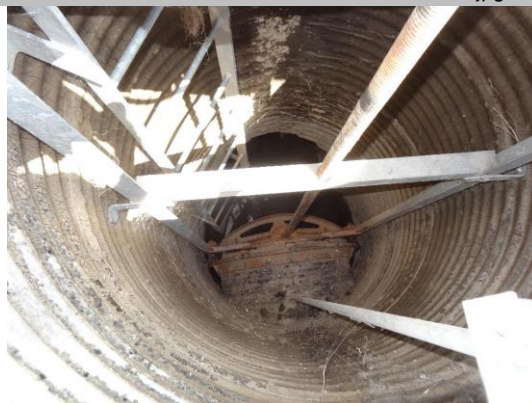
Photo 2 of 3 : UCIP_FA_2019_52830_71661.jpg

View of riser located on waterward side.

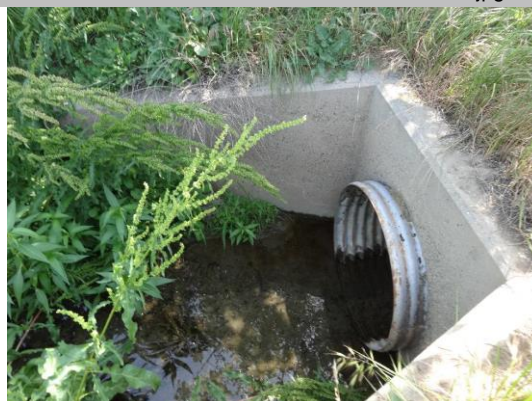
Photo 3 of 3 : UCIP_FA_2019_52830_71660.jpg

Pipe outlet on waterward side.

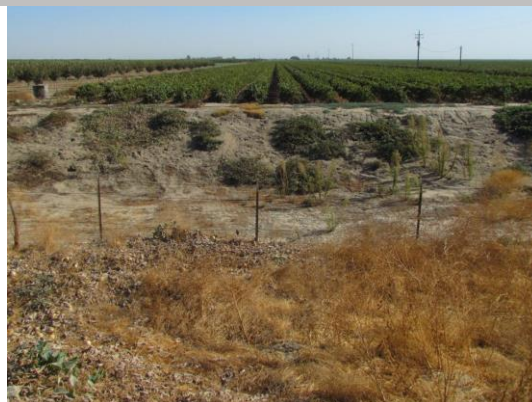
Photo 1 of 1 : FA_2019_NA0011_143_32_20190912_00023.jpg

LM Start	0.01	Rating **	U	Issue No.	32
LM End	0.03	Issue Type +	En	Location *	LS
Category	Earthen Levee			GPS Latitude/Longitude	
				Start	End
Item	Encroachments			37.045531 °	37.045620 °
				-120.427244 °	-120.426900 °
DWR ID	DWR_NA0011_02_f_2012_32				
Comment Code					
DT : Ditch					
Inspector Comment					
There is a settling basin on the landward side of the levee. This basin is very close to the landside easement.

Ash Slough at levee mile 0.01- 0.03. Settling basin on the landside levee berm.

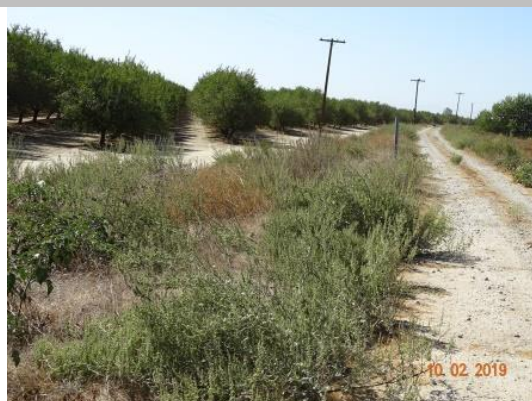
Photo 1 of 1 : FA_2019_NA0011_143_10_20191008_00050.jpg

Looking downstream along the landside slope. (Fall 2019)

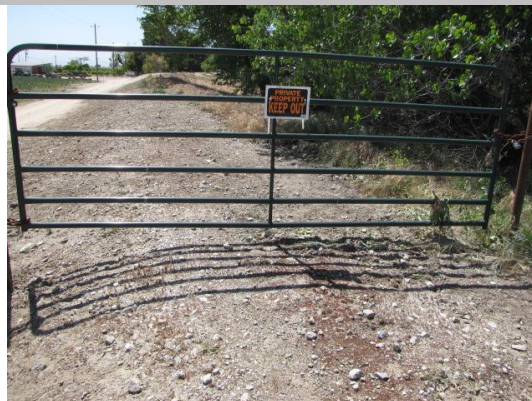
Photo 1 of 2 : FA_2019_NA0011_143_5_20190912_00005.jpg

LM Start	0.30	Rating **	M	Issue No.	5
LM End	0.30	Issue Type +	En	Location *	CR
Category	Earthen Levee			GPS Latitude/Longitude	
				Start	End
Item	Encroachments			37.047100 °	37.047100 °
				-120.422448 °	-120.422448 °
DWR ID	DWR_NA0011_02_f_2012_5				
Comment Code					
FE : Fence					
Inspector Comment					
This fence was not authorized by CVFPB. The District is aware of the fence. The landowner installed the fence and gate across the levee section because he has been broken into frequently and had many items stolen in the past. An inspector met with the landowner on 4-29-2014 and he let the inspector put a State lock on his gate to gain access to the levee.

Unauthorized gate and metal fence placed on slope and toe of levee section. Photo taken 4-17-2013.

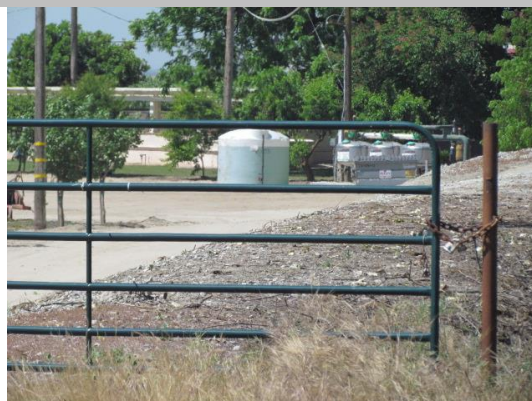
Photo 2 of 2 : FA_2019_NA0011_143_5_20190912_00006.jpg

New photo 5-4-2017.

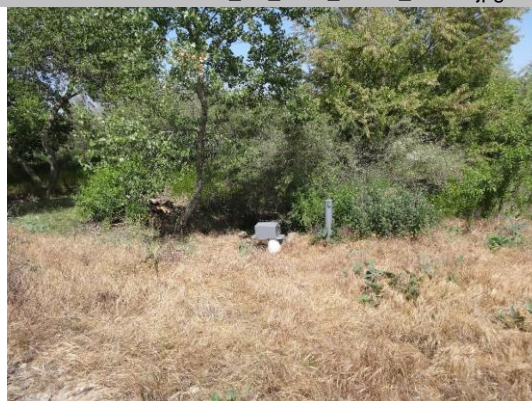
Photo 1 of 3 : UCIP_FA_2019_52834_64463.jpg

View of waterward side.

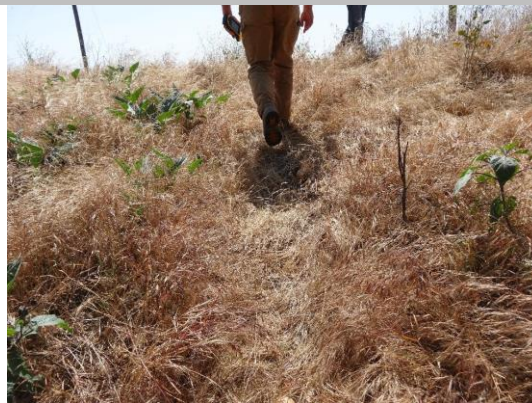
Photo 3 of 3 : UCIP_FA_2019_52834_64465.jpg

Dense vegetation on waterward slope.

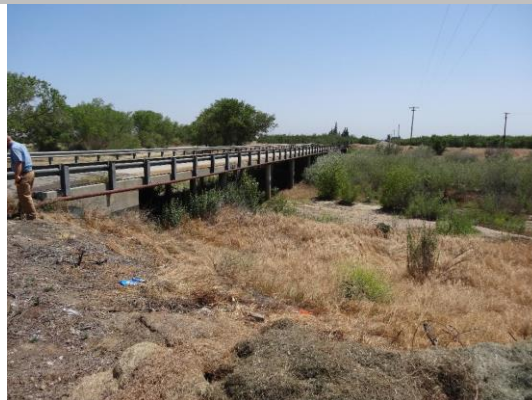
Photo 1 of 3 : UCIP_FA_2019_52839_71823.jpg

Conduit along face of bridge.

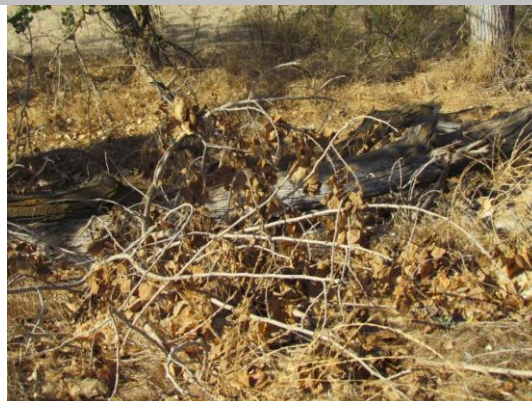
Photo 1 of 2 : FA_2019_NA0011_143_27_20190912_00018.jpg

Unit 2 Ash Slough Levee mile 0.98 waterside shoulder and slope.

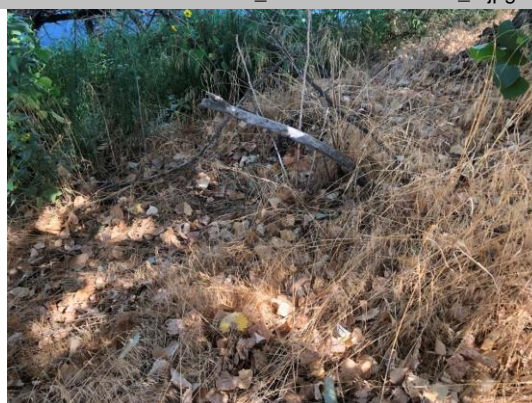
Photo 1 of 3 : SJR2019_NA0011U02RM2.57_2.jpg

View of the erosion site from the levee crest.

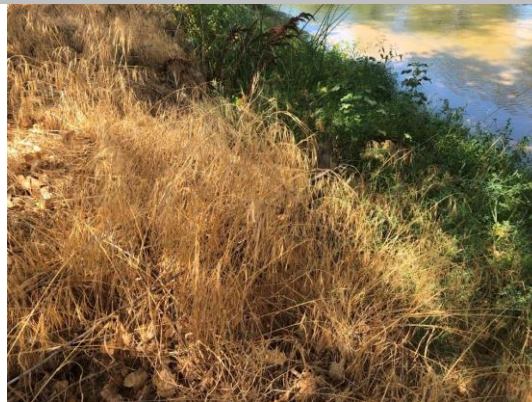
Photo 3 of 3 : SJR2019_NA0011U02RM2.57_3.jpg

Close-up view of the site.

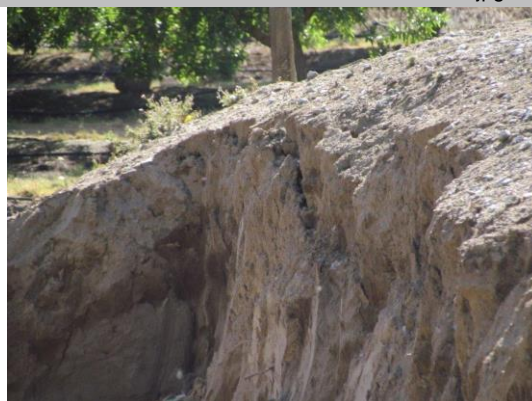
Photo 3 of 3 : UCIP_FA_2019_52842_75224.jpg

Close-up view of cut on LS slope at U2 LM 1.49 (the most downstream end of open trench, photo 2 of 2)

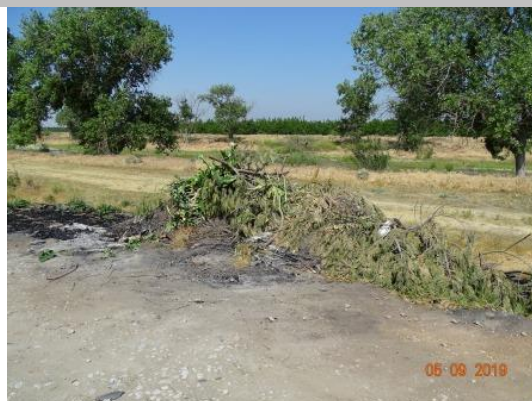
Photo 1 of 1 : FA_2019_NA0011_143_41_20190912_00028.jpg

Prunings for a burn pile left on waterside shoulder and slope of levee.
(Spring 2019)

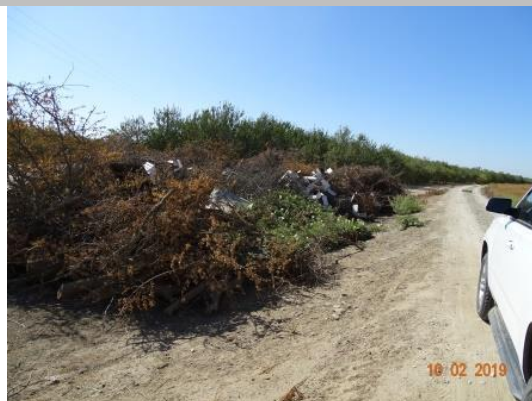
Photo 1 of 2 : FA_2019_NA0011_143_24_20191008_00051.jpg

View of prunings and trash piled along the landside levee toe. (Fall 2019)

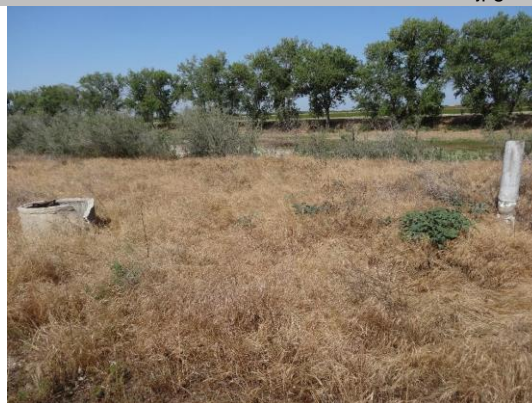
Photo 1 of 3 : UCIP_FA_2019_52844_71815.jpg

Standpipes visible on waterward side.

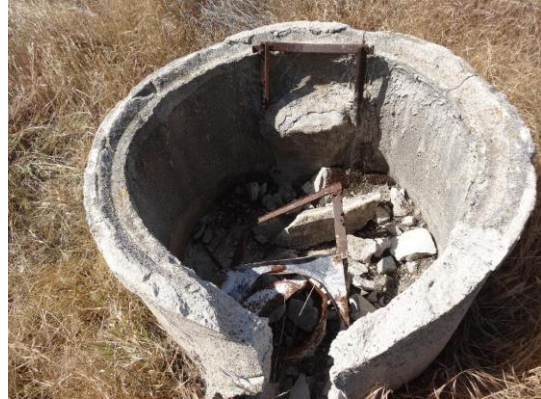
Photo 2 of 3 : UCIP_FA_2019_52844_71820.jpg

36-inch pipe full of concrete debris located on waterward side.

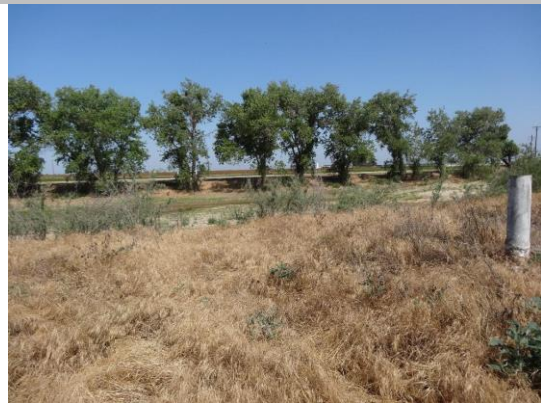
Photo 3 of 3 : UCIP_FA_2019_52844_71819.jpg

View of waterward side.

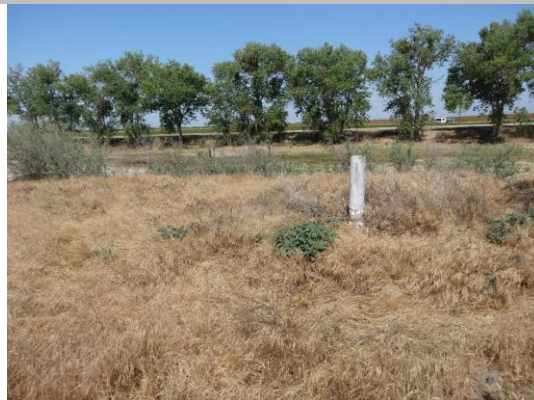
Photo 1 of 3 : UCIP_FA_2019_52845_71809.jpg

Tall concrete standpipe visible on waterward side.

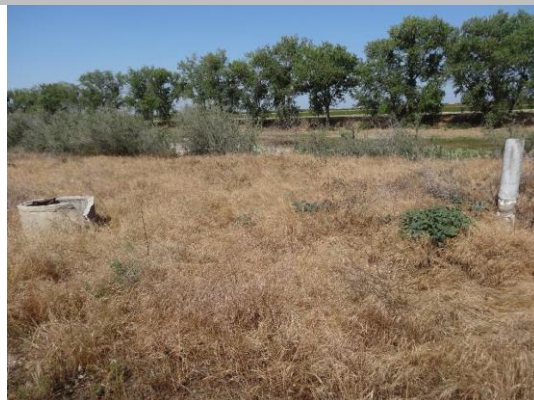
Photo 2 of 3 : UCIP_FA_2019_52845_71808.jpg

Concrete standpipes visible on waterward side--dense vegetation on waterward side.

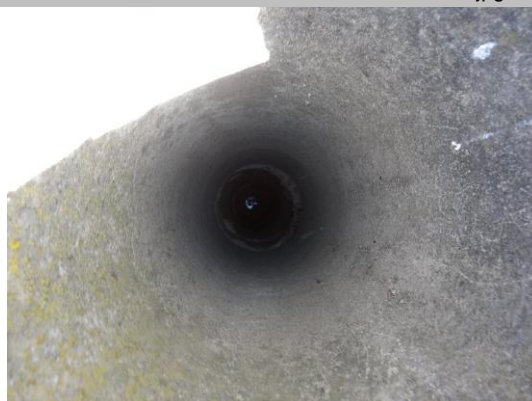
Photo 3 of 3 : UCIP_FA_2019_52845_71807.jpg

Inside view of 10-inch concrete standpipe.

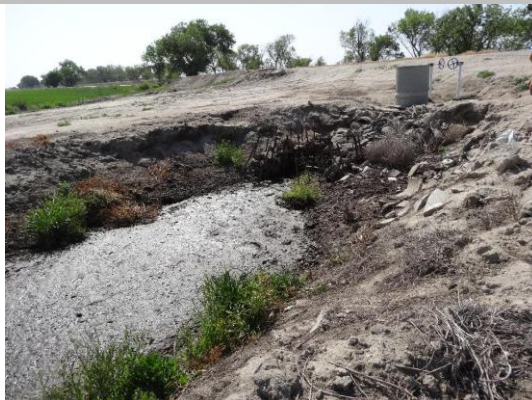
Photo 3 of 3 : UCIP_FA_2019_52829_64474.jpg

Canal located on landward side.

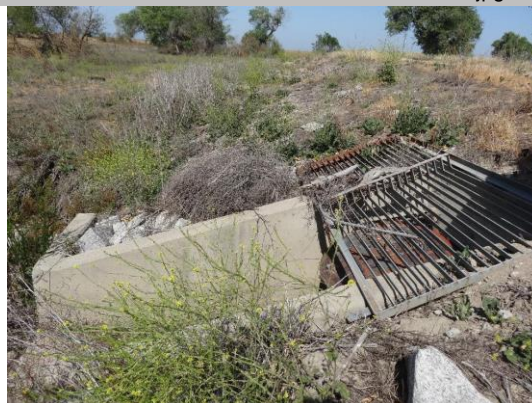
Photo 2 of 3 : UCIP_FA_2019_52832_69687.jpg

Debris screen visible on waterward headwall.

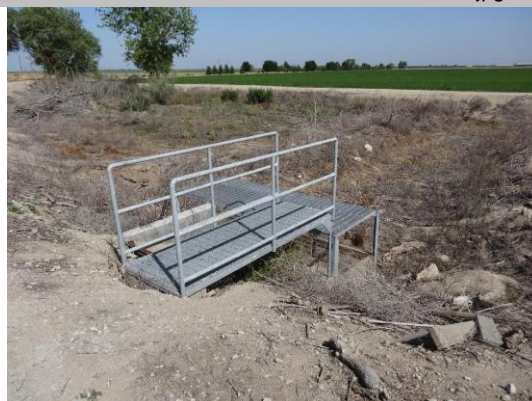
Photo 3 of 3 : UCIP_FA_2019_52832_69688.jpg

View of landward side.

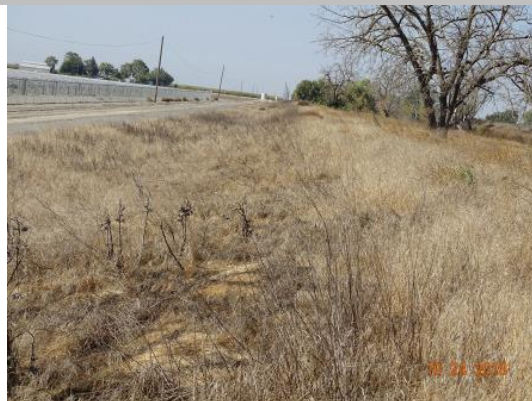
Photo 2 of 2 : FA_2019_NA0011_145_5_20190912_00005.jpg

View of wild growth on landside slope and shoulder. (Fall 2018)

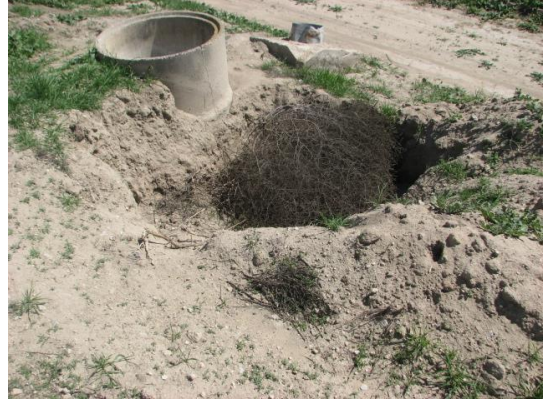
Photo 1 of 3 : FA_2019_NA0011_145_22_20190912_00021.jpg

Looking west at large hole next concrete riser (no pipe) on landward slope. (Spring 2018)

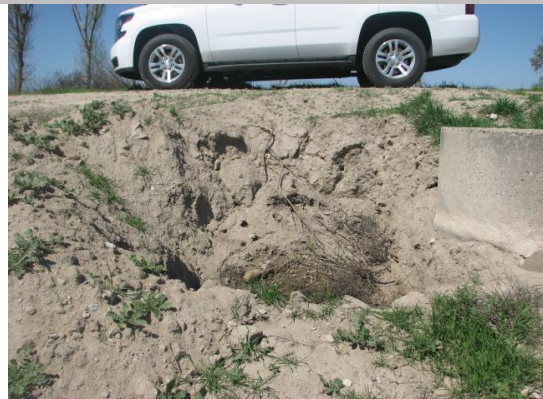
Photo 3 of 3 : FA_2019_NA0011_145_22_20190912_00023.jpg

Looking east at large hole next to riser (no pipe) on landward slope. (Spring 2018)

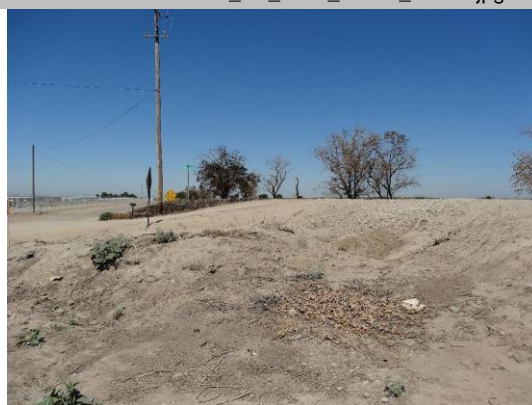
Photo 1 of 3 : UCIP_FA_2019_53154_75760.jpg

View of LS slope.

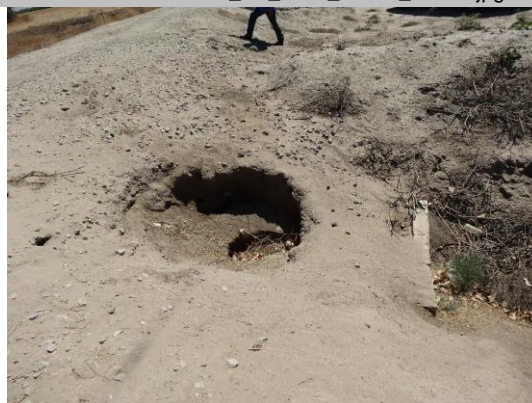
Photo 3 of 3 : UCIP_FA_2019_53154_75762.jpg

Sink hole located immediately above concrete headwall visible on LS.

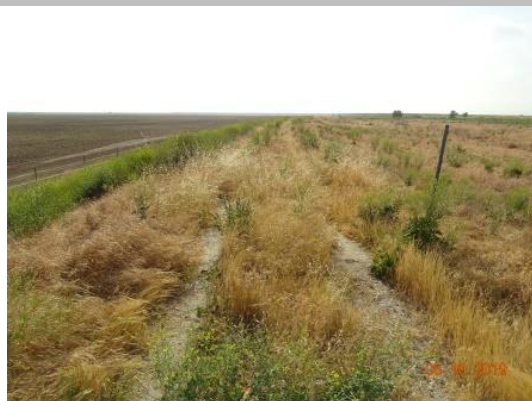
Photo 2 of 2 : FA_2019_NA0011_146_42_20190912_00019.jpg

View of levee crown looking downstream. (Spring 2019)

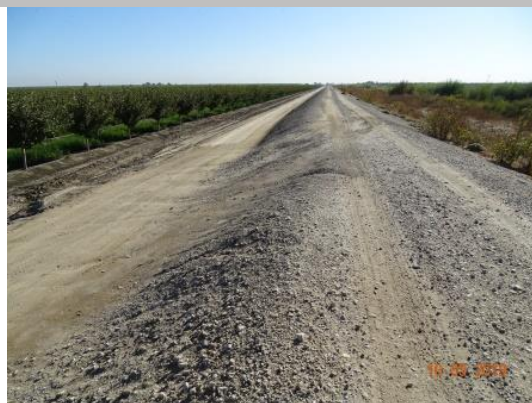
Photo 1 of 2 : FA_2019_NA0011_146_18_20191009_00039.jpg

Damage to landside shoulder and slope looking upstream. (Fall 2019)

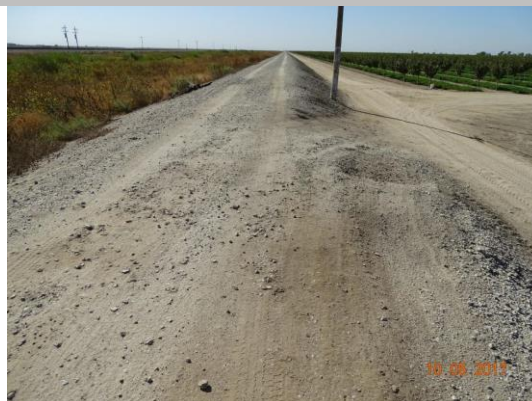
Photo 2 of 2 : FA_2019_NA0011_146_18_20190912_00007.jpg

Repair damage from vehicle traffic on slope and shoulder. (Fall 2017)

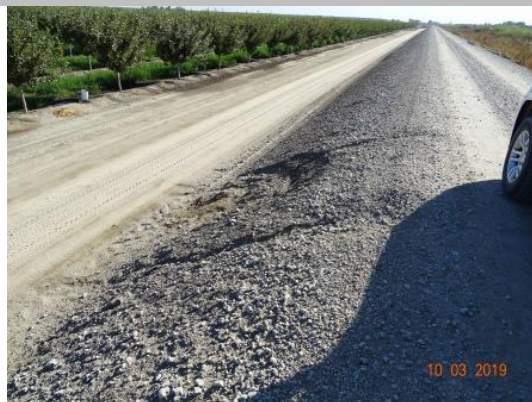
Photo 1 of 2 : FA_2019_NA0011_146_17_20191009_00041.jpg

View of landside slope erosion looking upstream. (Fall 2019)

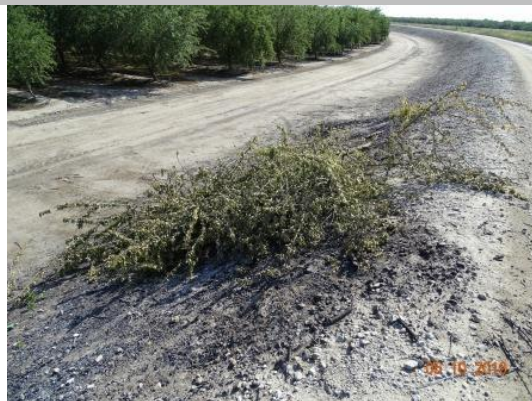
Photo 1 of 2 : FA_2019_NA0011_146_30_20190912_00014.jpg

Pruning pile starting to accumulate on landside slope. (Spring 2019)

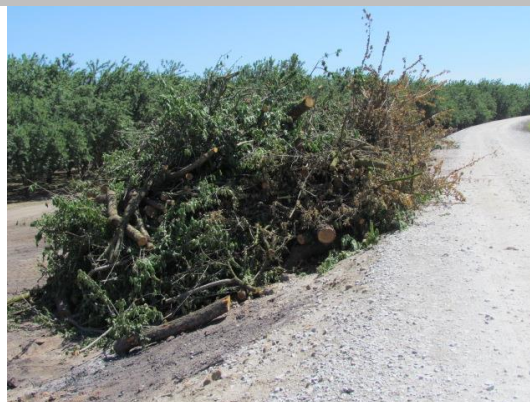
Photo 1 of 1 : FA_2019_NA0011_146_35_20190912_00016.jpg

Burn pile on LS slope.

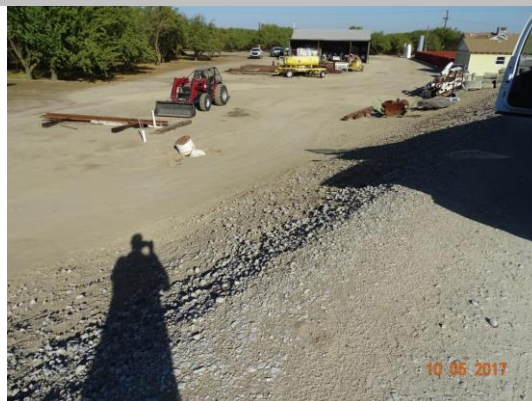
Photo 1 of 2 : FA_2019_NA0011_146_25_20190912_00010.jpg

Possible sinkhole 10 feet from landside levee toe. 6 ft long by 1-2 ft wide by 5.5 ft deep. White 55gal drum halves were placed in hole for safety.

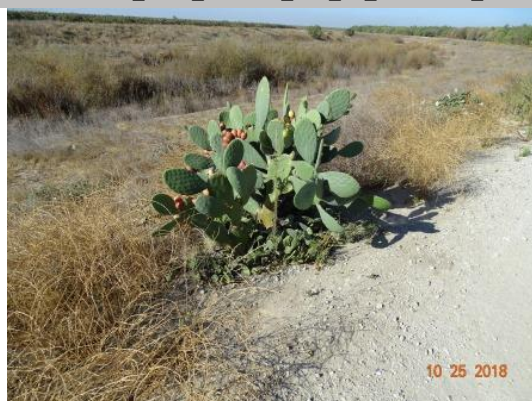
Photo 2 of 2 : FA_2019_NA0011_146_10_20190912_00002.jpg

Cactus on waterside slope. (Fall 2018)

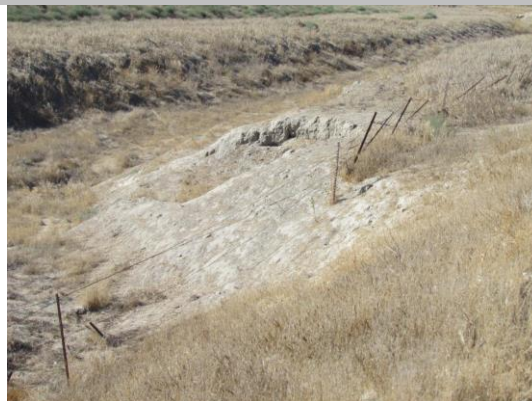
Photo 1 of 1 : FA_2019_NA0011_147_20_20190912_00005.jpg

Looking downstream at the old erosion site landside slope.

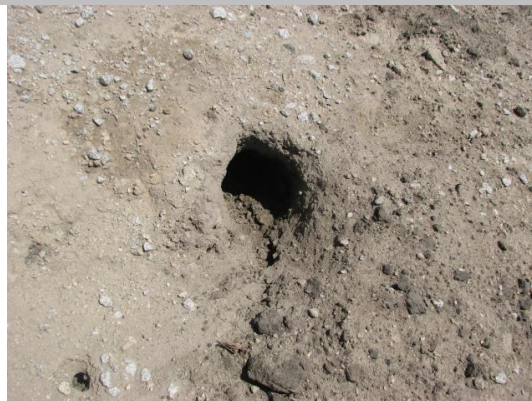
Photo 1 of 1 : FA_2019_NA0011_147_53_20190912_00022.jpg

Looking at typical rodent hole on landward slope. (Spring 2018)

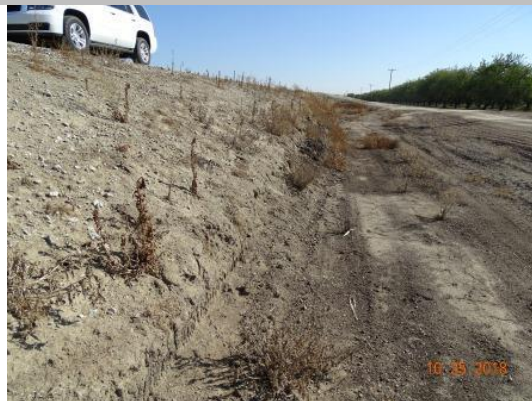
Photo 1 of 1 : FA_2019_NA0011_147_37_20190912_00013.jpg

Agricultural equipment cutting into levee slope. (Fall 2018)

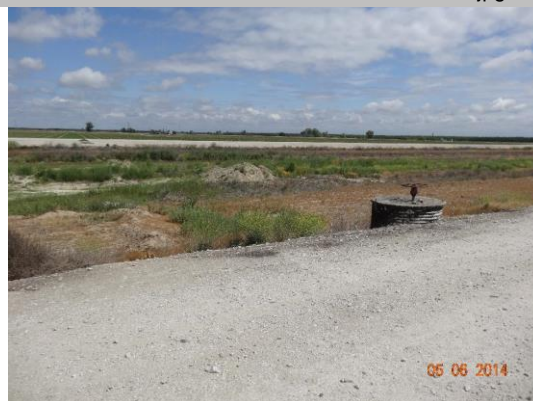
Photo 1 of 3 : UCIP_FA_2019_52854_64570.jpg

View of waterward side.

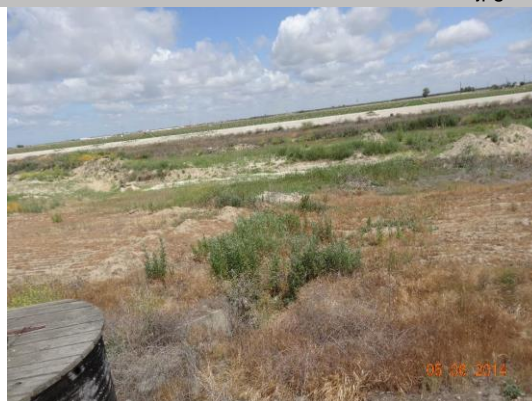
Photo 3 of 3 : UCIP_FA_2019_52854_64572.jpg

Overview of channel at crossing.

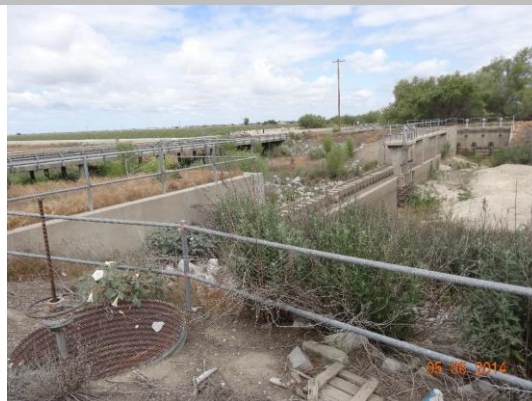
Photo 1 of 3 : UCIP_FA_2019_52855_69722.jpg

View of WS.

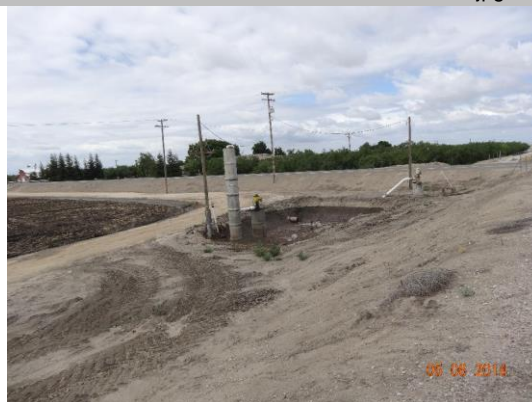
Photo 3 of 3 : UCIP_FA_2019_52855_69723.jpg

Additional structures found on LS.

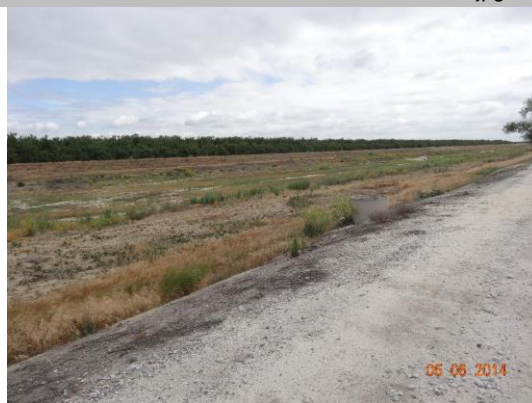
Photo 1 of 3 : UCIP_FA_2019_52860_64585.jpg

View of waterward side.

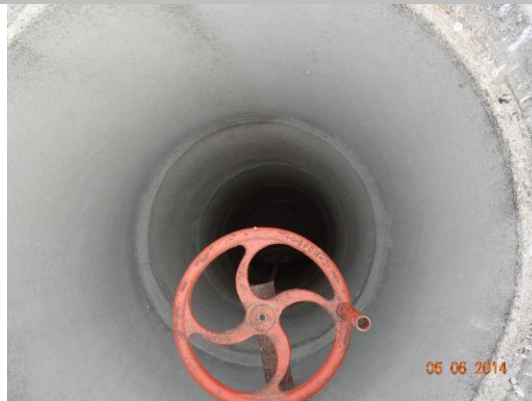
Photo 3 of 3 : UCIP_FA_2019_52860_64584.jpg

Inside view of standpipe located on waterward side.

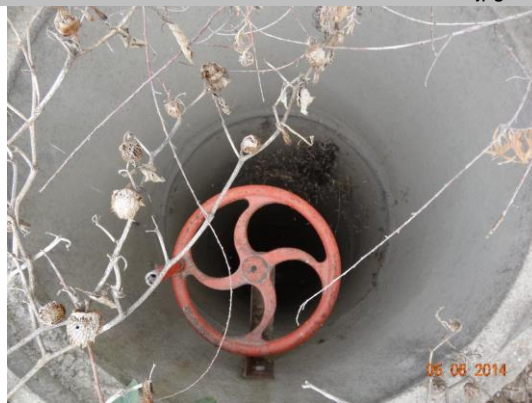
Photo 2 of 3 : UCIP_FA_2019_52861_64589.jpg

Inside view of standpipe located on waterward side.

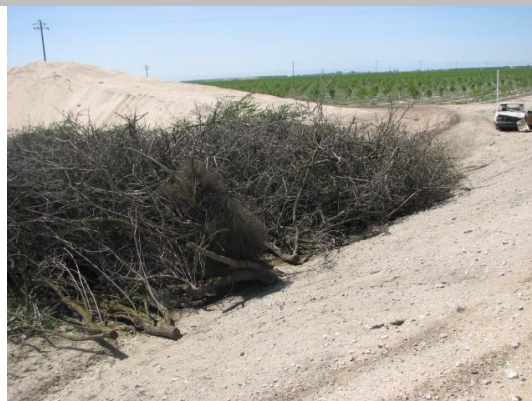
Photo 1 of 2 : FA_2019_NA0011_147_52_20190912_00020.jpg

Looking upstream at prunings at landward toe. (Spring 2018)

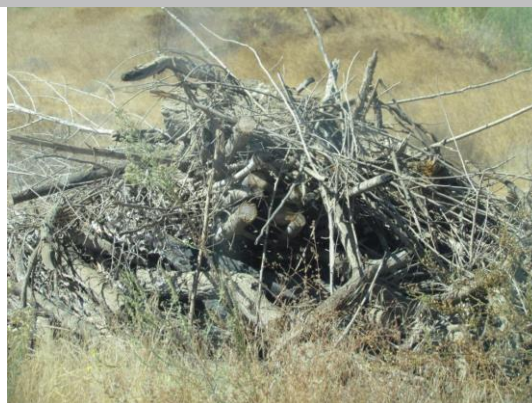
Photo 1 of 1 : FA_2019_NA0011_147_31_20190912_00009.jpg

Fresno River levee mile 8.09.

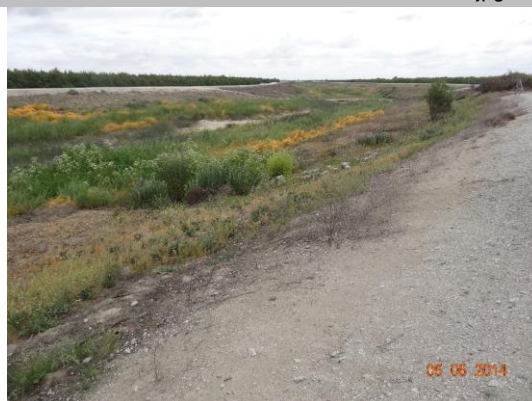
Photo 1 of 3 : UCIP_FA_2019_52864_64596.jpg

View of waterward side.

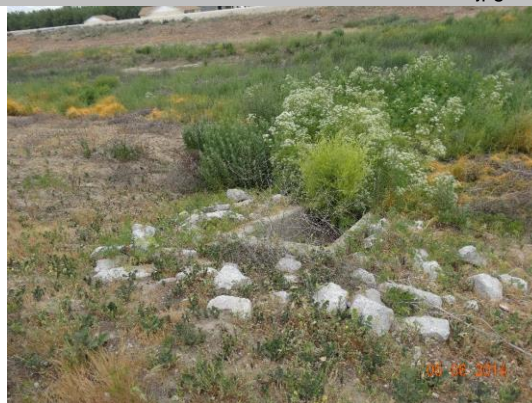
Photo 2 of 3 : UCIP_FA_2019_52864_64599.jpg

Rip rap around concrete headwall located on waterward side.

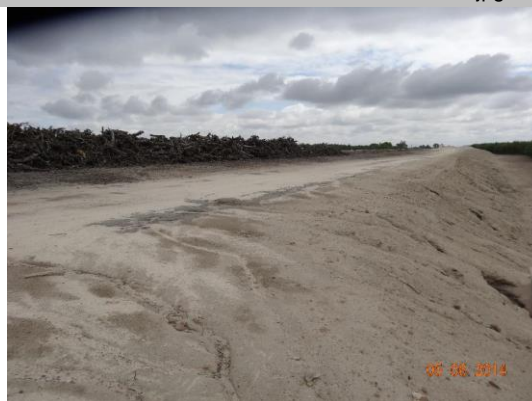
Photo 3 of 3 : UCIP_FA_2019_53156_64603.jpg

View of LS.

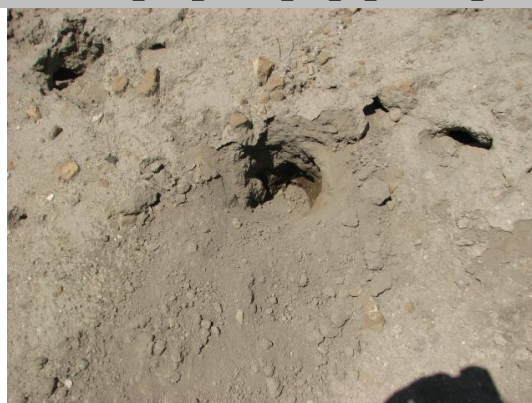
Photo 1 of 1 : FA_2019_NA0011_147_51_20190912_00019.jpg

Looking at typical rodent holes on landward slope. (Spring 2018)
